**DRAFT FINAL**  
**Coal Ash Impoundment**  
**Specific Site Assessment**  
**Report**  
**Arizona Public Service**  
**Cholla Power Plant**

Submitted by:  
**GEI Consultants, Inc.**  
6950 South Potomac Street, Suite 300  
Centennial, CO 80112

October 2009  
Project 091330

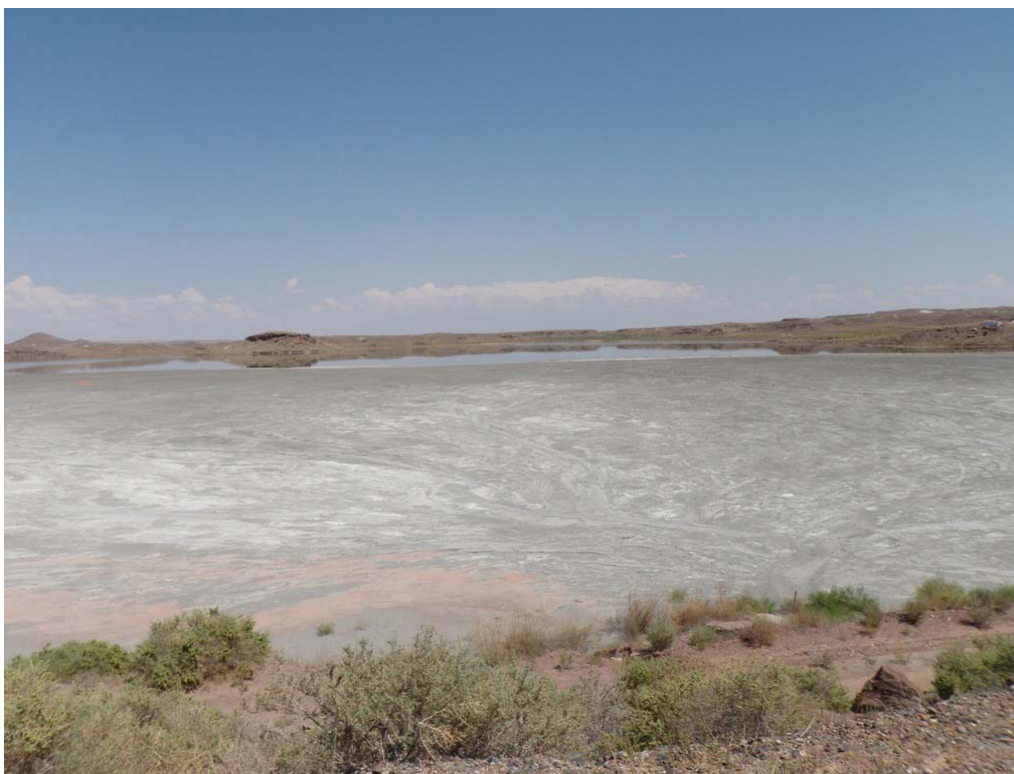
**Photo 1 –Fly Ash Pond: Overview looking north from embankment. Note downstream fly ash beach.**

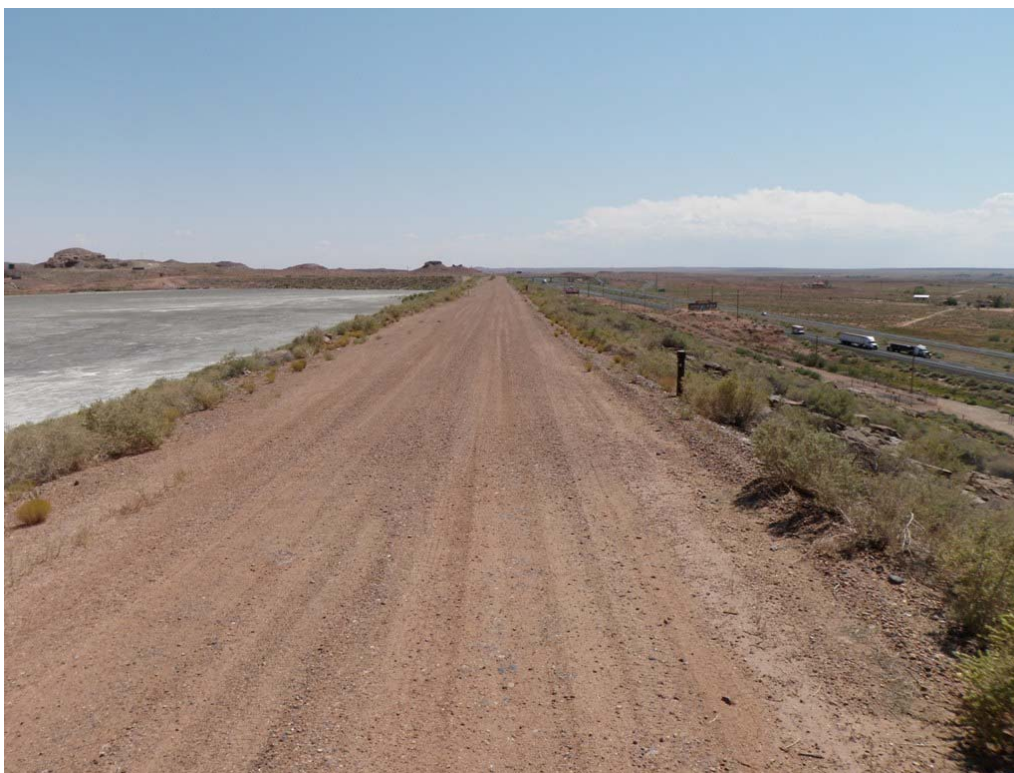
**Photo 2 –Fly Ash Pond Dam: Crest of embankment with dirt road, looking east.**

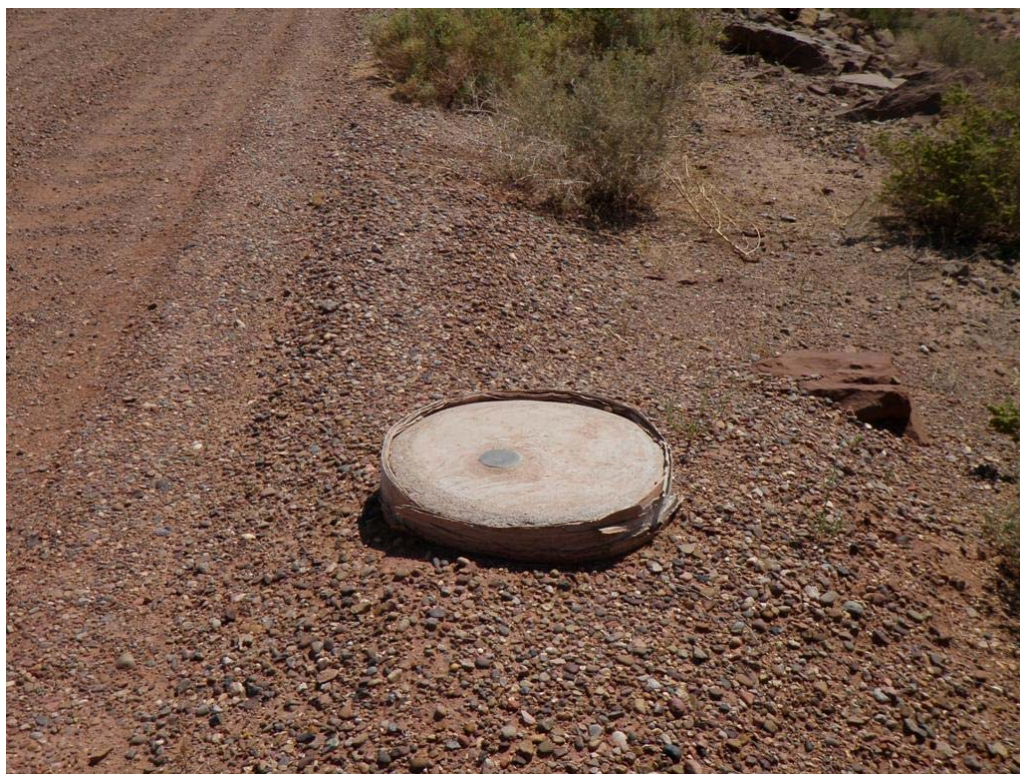
**Photo 3- Movement monument on Fly Ash Pond Dam.**

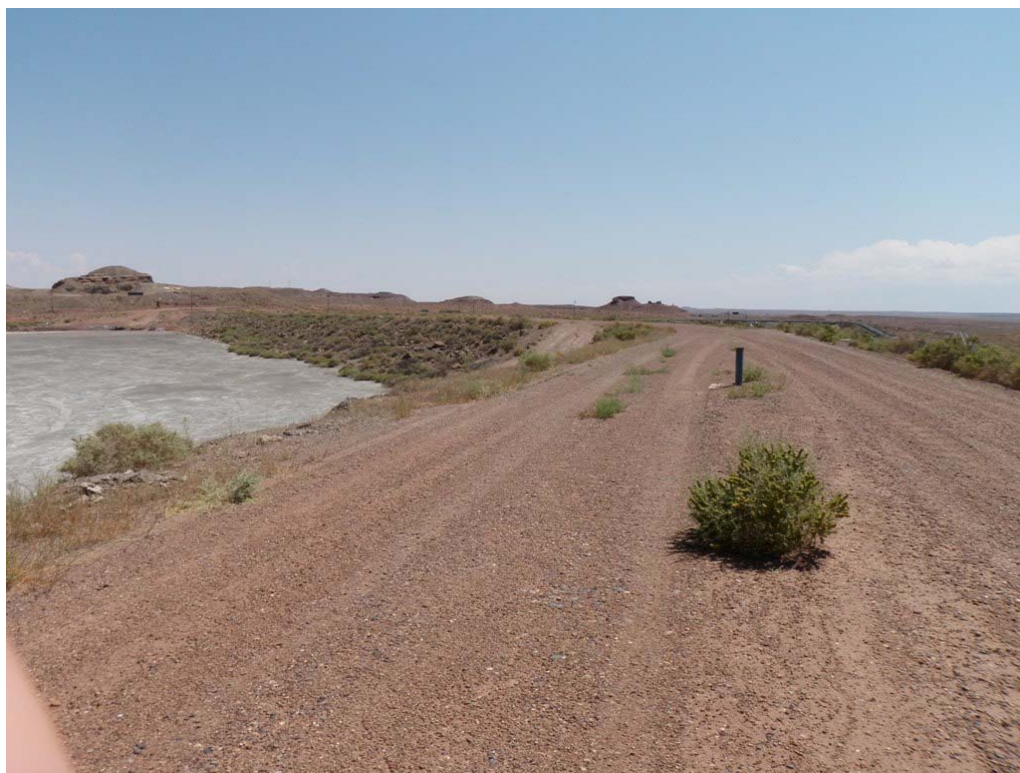
**Photo 4 –Crest of Fly Ash Pond Dam with piezometer, looking east at bend in embankment.**

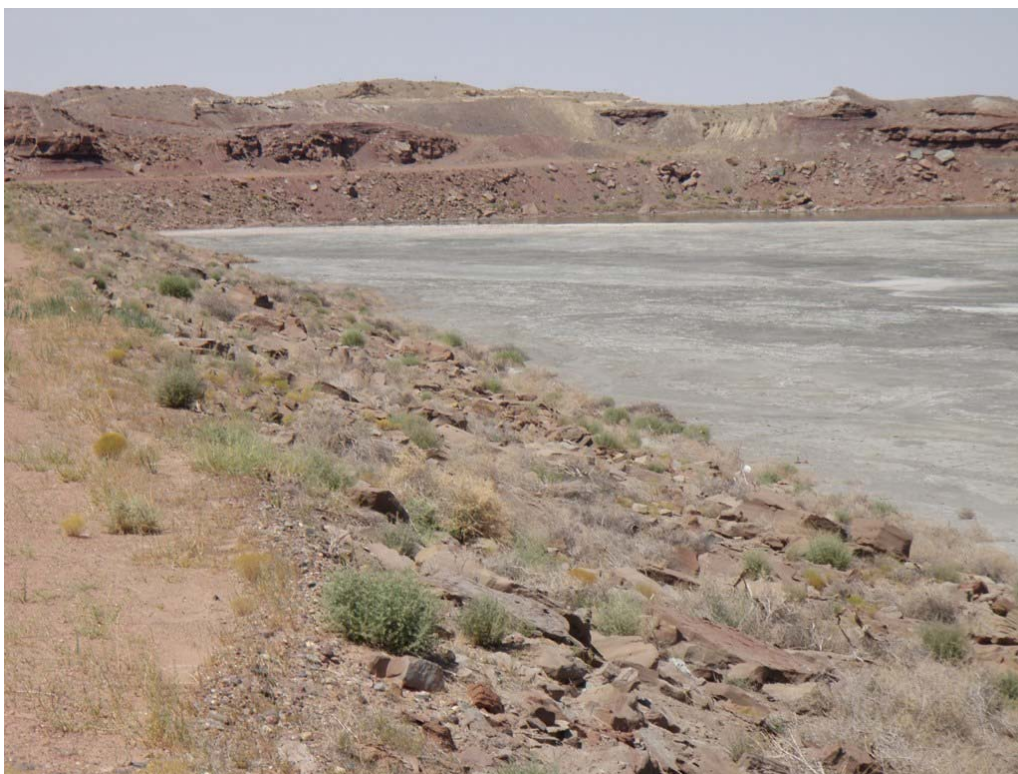
**Photo 5 –Fly Ash Pond Dam: Upstream slope, looking west. Note vegetation.**

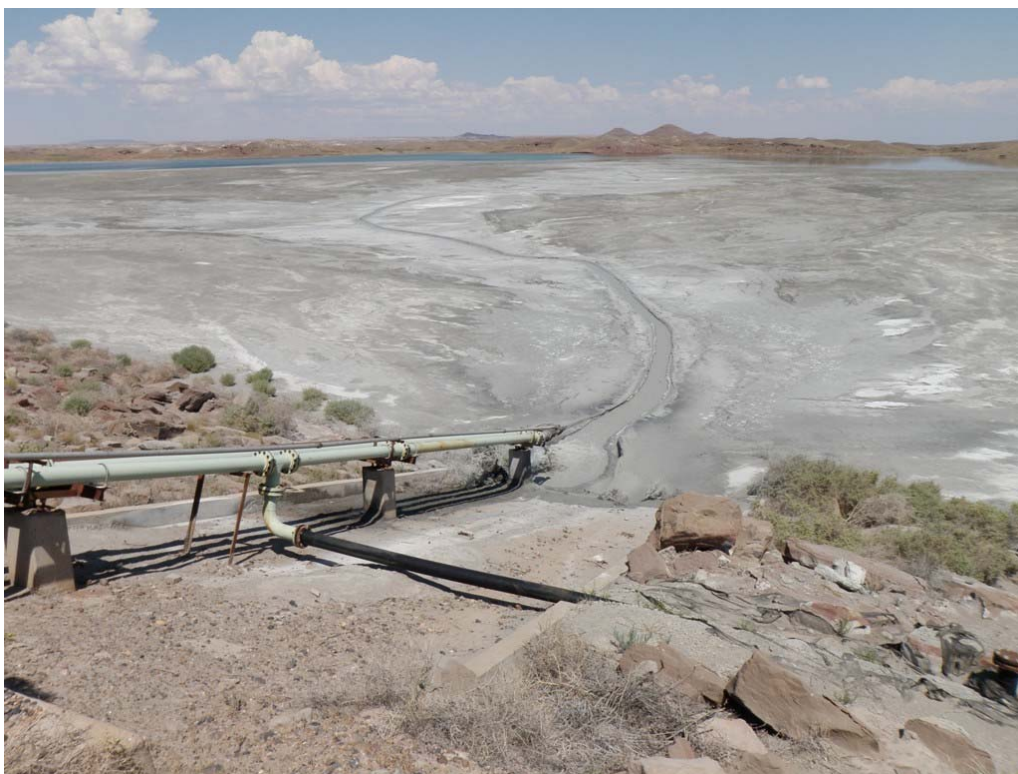
**Photo 6 – Fly Ash Pond Dam: Slurry discharge point on upstream face.**

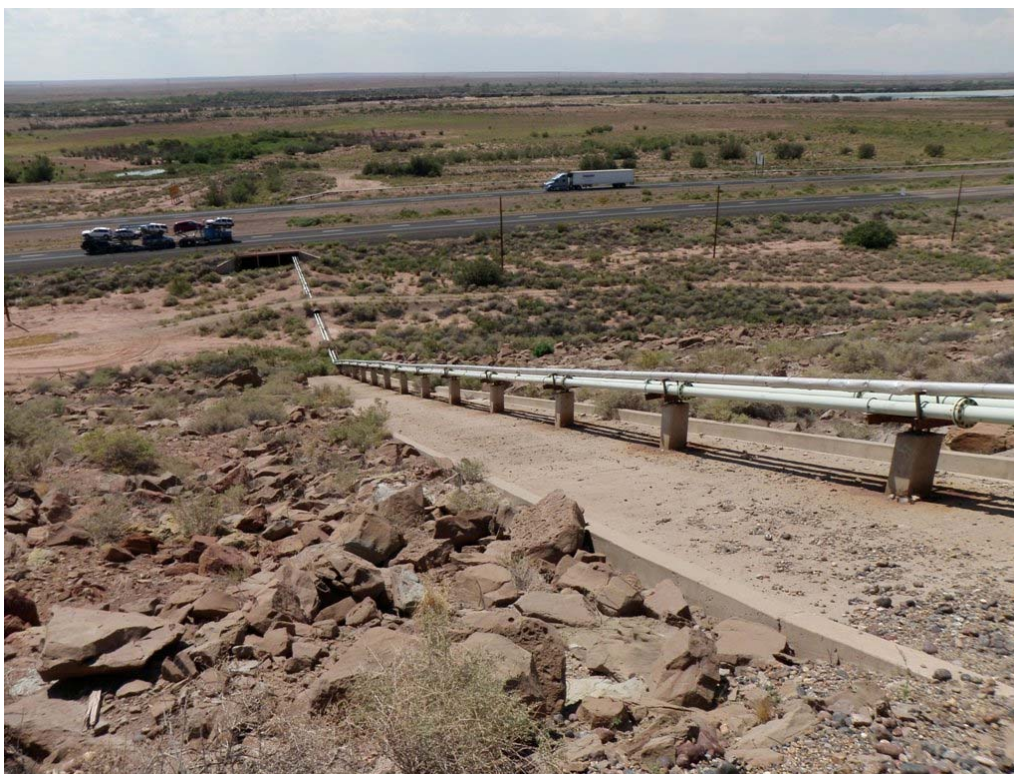
**Photo 8 – Fly Ash Pond Dam: Slurry pipes on downstream face.**

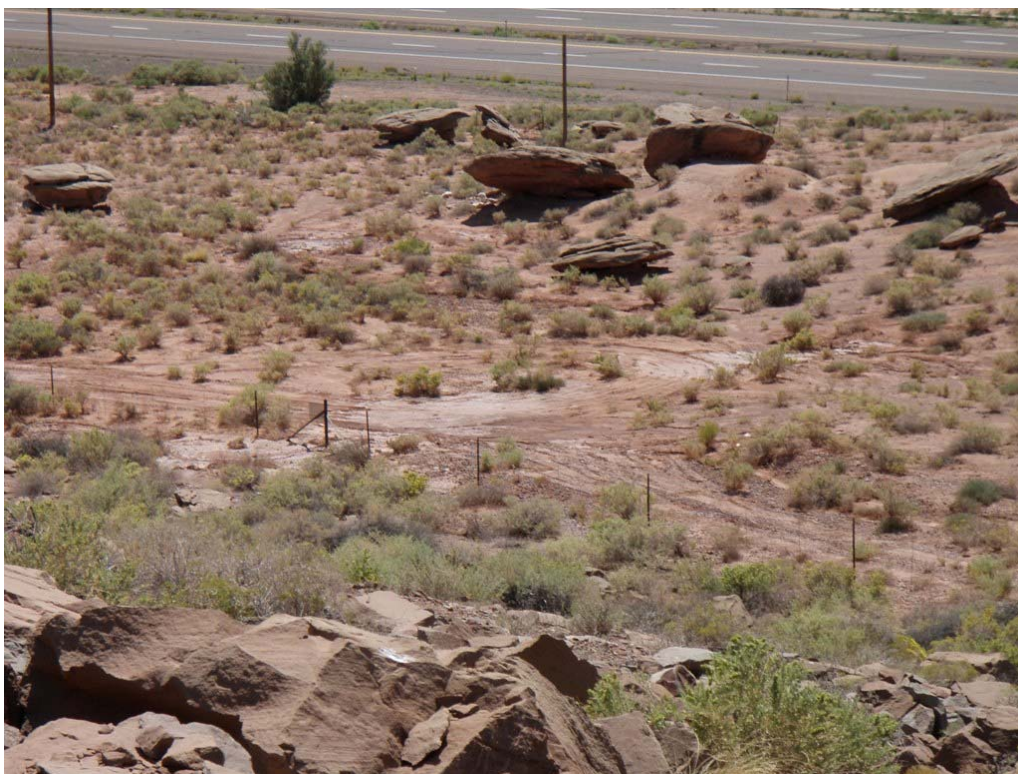
**Photo 19 – Fly Ash Pond: Salt patch associated with seepage near right abutment toe (known as the “Hoodoo Salt Patch”).**

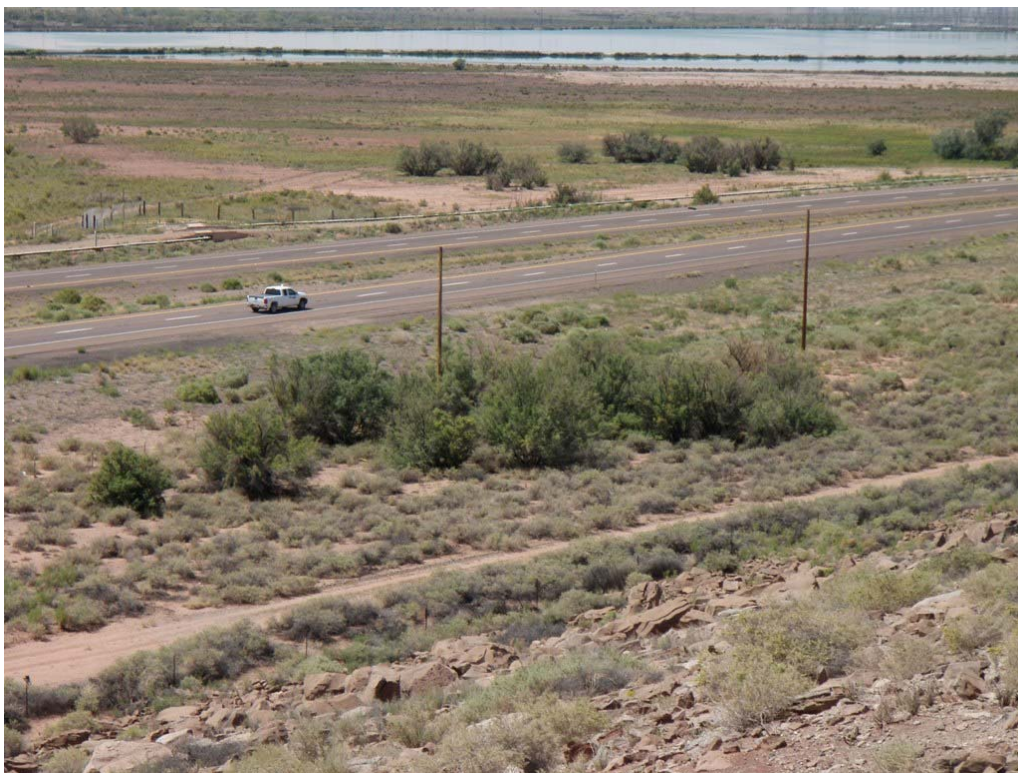
**Photo 20 – Fly Ash Pond: Tamarisks near downstream toe indicating seepage.**

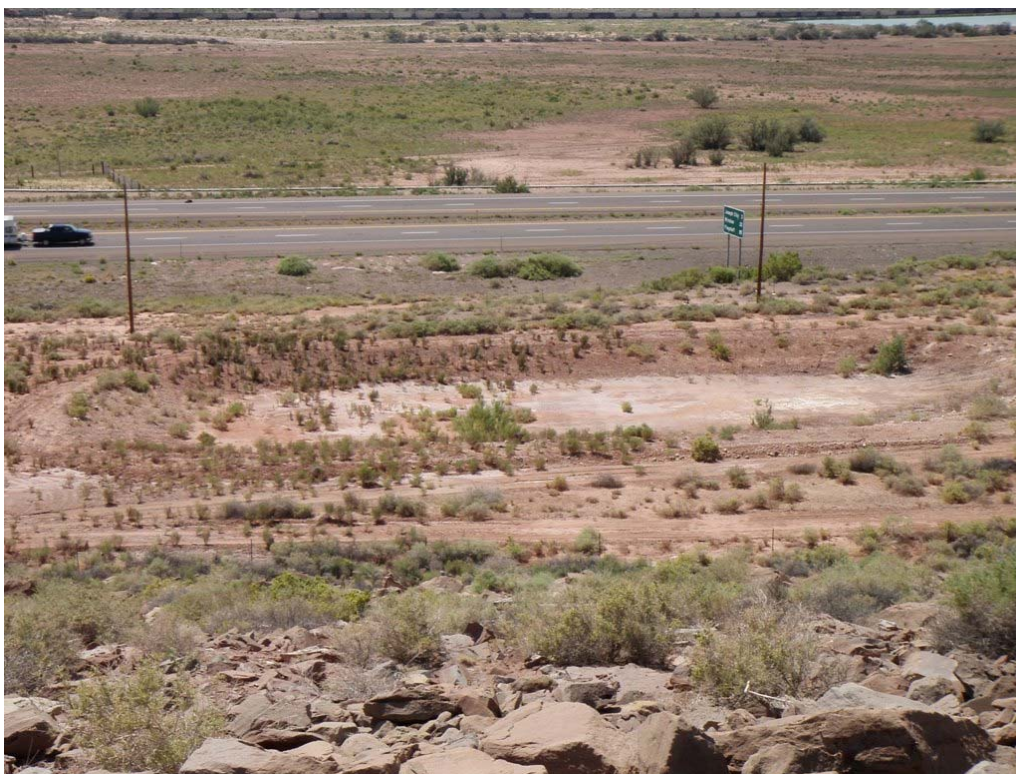
***I-40 Seep:*** The I-40 Seep is located just beyond the downstream toe of the Fly Ash Pond Dam at the right abutment. This seep does not have drain system to return water to the pond, but an evaporation pond was constructed to collect seepage in this area (Photo 21).

**Photo 21 – Fly Ash Pond: Evaporation Pond for I-40 Seep.**

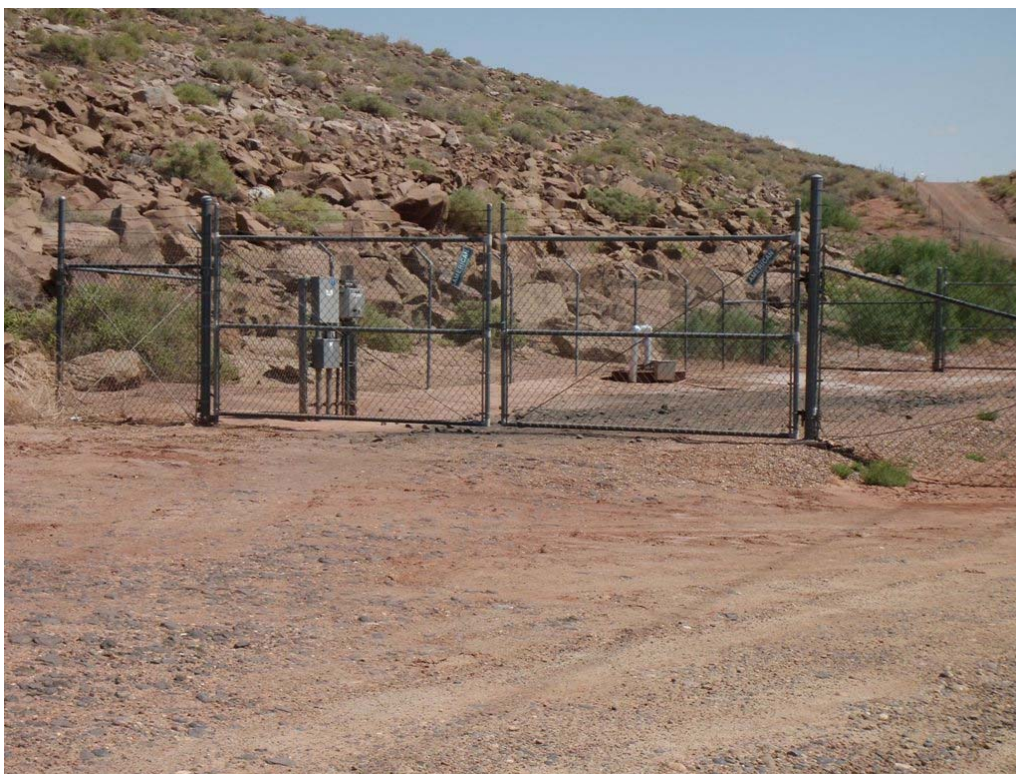
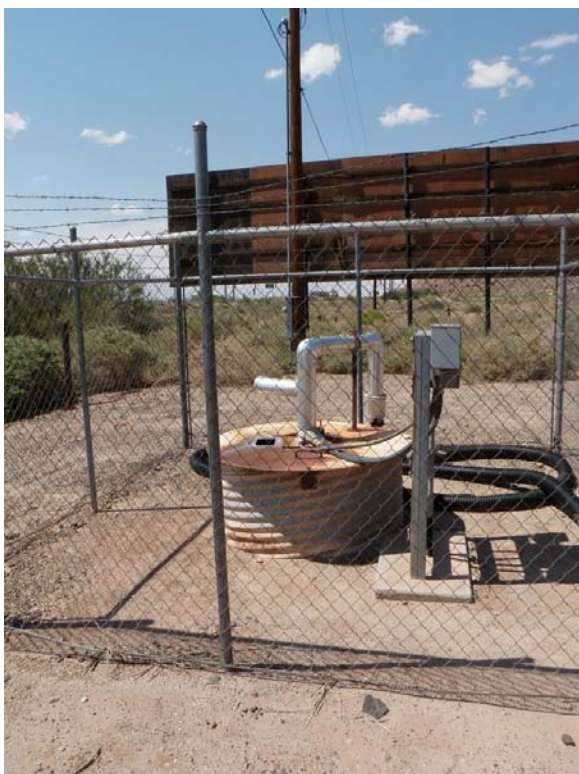
***Geronimo Seep:*** The Geronimo Seep is located less than 50 feet beyond the downstream toe of the Fly Ash Pond Dam, about 2,000 feet from the right abutment. An underground french drain system and wellpoints have been installed to monitor and collect the seepage in this area (Photos 22 and 23). Relatively large flows (up to about 47 gpm) have been measured at this location, but APS indicates that the totalizer at this location has malfunctioned recently and readings may not be accurate. No flowing surface water was observed at this seep location at the time of our assessment.

**Photo 22 – Fly Ash Pond: Seepage collection system for Gironimo Seep.**

**Photo 23 – Fly Ash Pond: Seepage collection system for Gironimo Seep.**

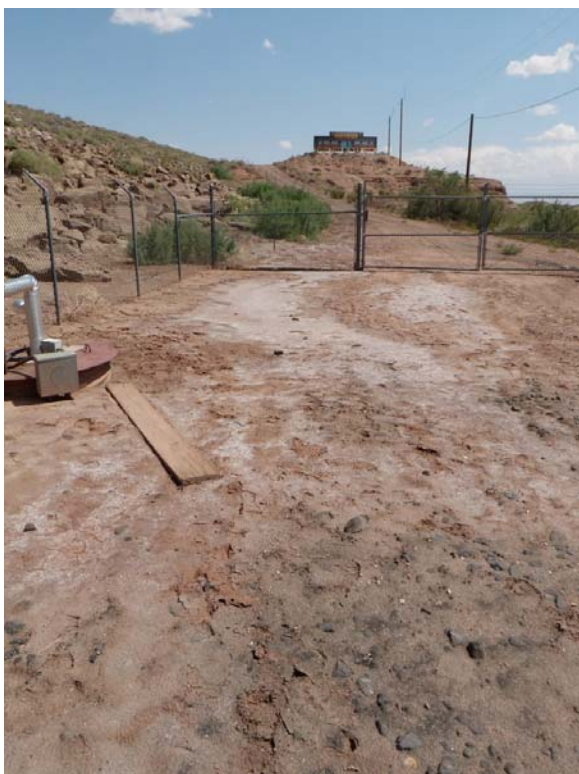
***Hunt Seep:*** The Hunt Seep is located more than 1,500 feet beyond the downstream toe of the Fly Ash Pond Dam. The previously-damp soil indicating the seep in this area is shown in Photo 24. An underground french drain system is used to monitor and collect seepage in this area. No flowing water was observed at the time of the dam assessment at this location. The

**Photo 24 – Fly Ash Pond: Hunt Seep area. Note seepage collection system on left.**

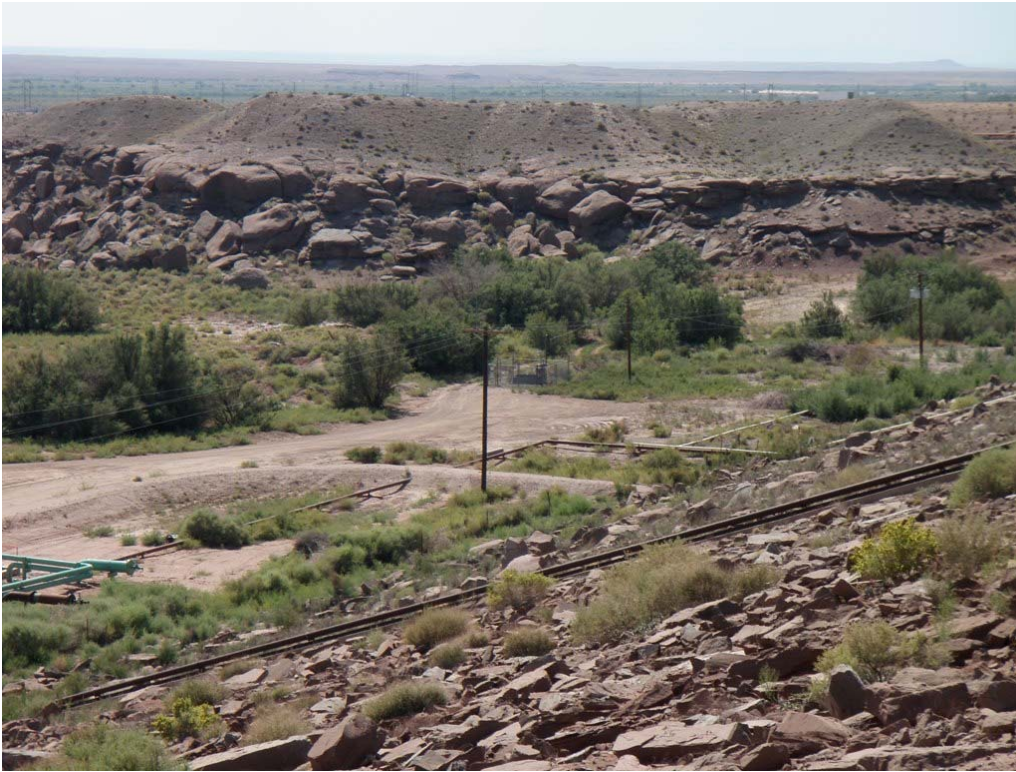
**West Abutment Seep:** The West Abutment Seep is located about 100 feet downstream of the Bottom Ash Pond Dam toe (Photo 25). APS monitors the flow that daylights in this area by means of a weir (Photo 26), in addition to an underground french drain system several hundred feet east along the face (Photo 27). The general West Abutment Seep area is shown in Photo 28. We observed water flowing through the weir at the time of our site visit, and a rough measurement indicated that the flow at this time was less than 2 gpm. Flows in the weir are typically 4 gpm or less, and the totalizer at this location has measured a maximum of about 16 gpm since 1996.

**Photo 25 – Bottom Ash Pond: West Abutment Seep from embankment crest. Siphon pipes (center) and siphon collection system (lower left) are also visible.**

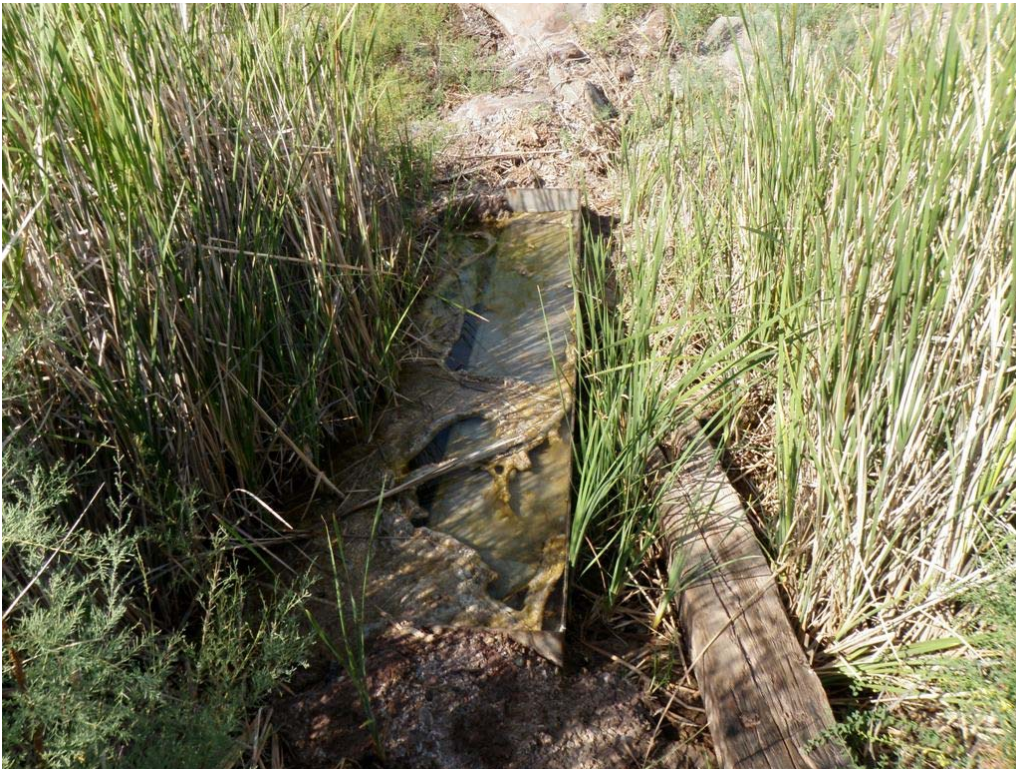
**Photo 26 – Bottom Ash Pond: Weir at West Abutment Seep.**

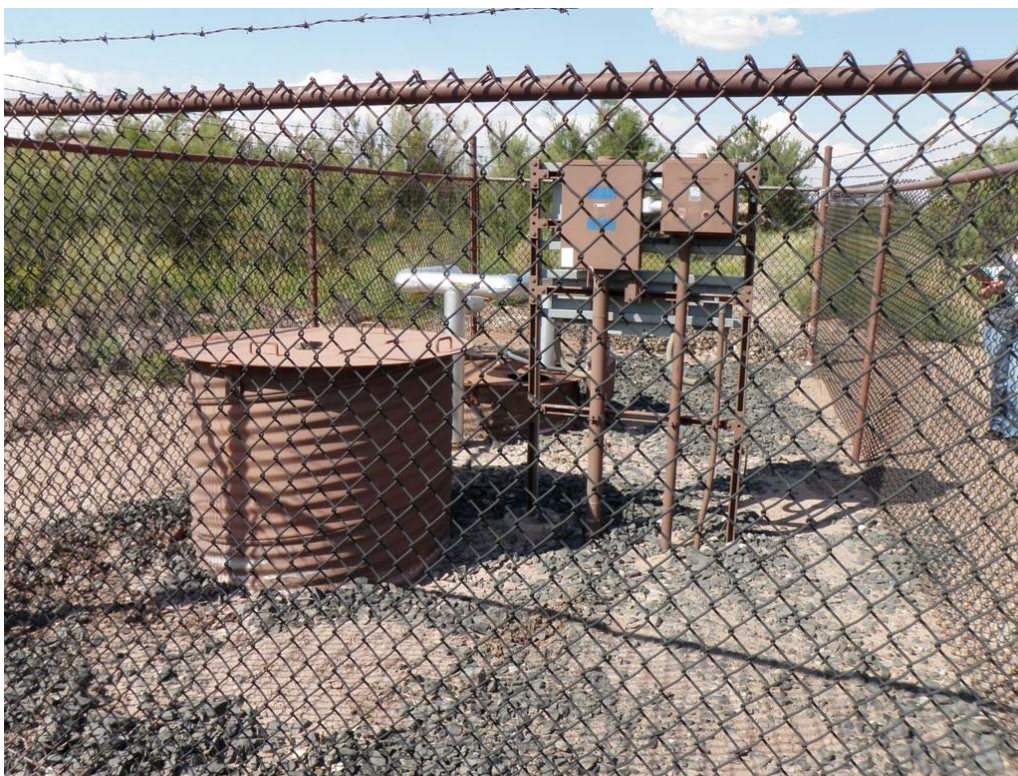
**Tanner Wash Seep:** The Tanner Wash Seep is located about 350 feet beyond the toe of the Bottom Ash Pond Dam near the left abutment. Seepage is collected and measured via an underground french drain system with a totalizer (Photo 29). Both salt patches (Photo 30) and flowing surface water (Photo 31) were observed at this seep at the time of our assessment. A maximum flow of about 15 gpm has been measured at this location since 1995. This seep is far enough from the dam that it is not considered a dam safety concern. This seep is of more environmental concern than others due to its vicinity to Tanner Wash (Photo 32).

**Photo 29 – Bottom Ash Pond: Seepage collection system for Tanner Wash Seep.**

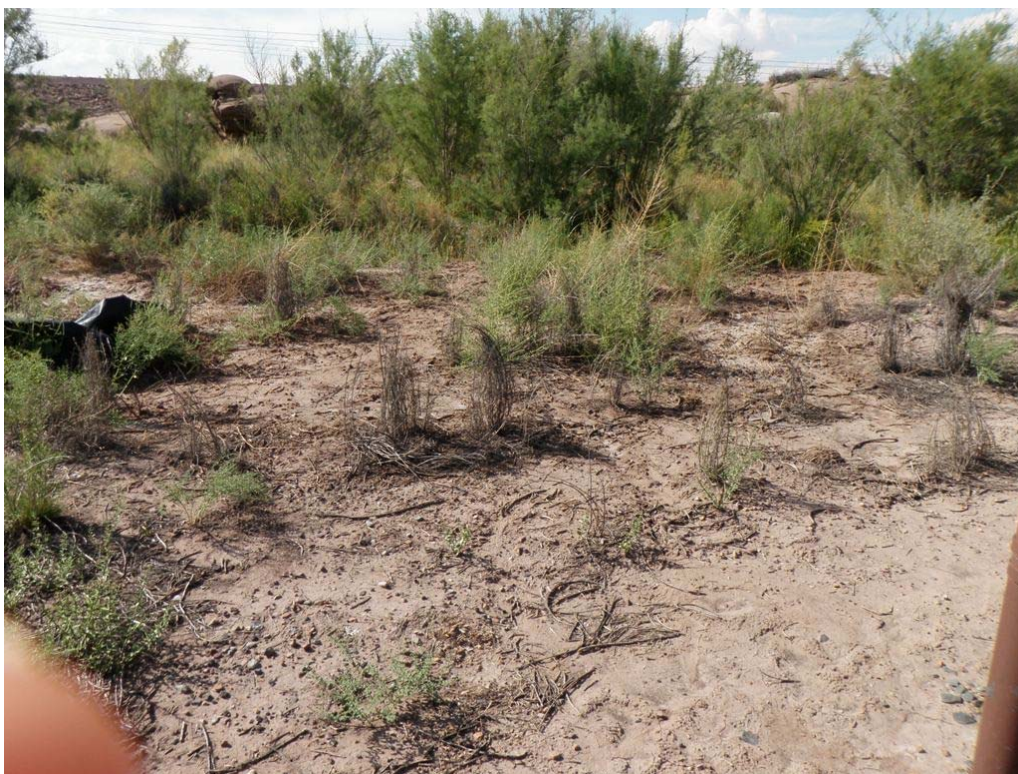
**Photo 30 – Bottom Ash Pond: Salt patches at Tanner Wash Seep.**

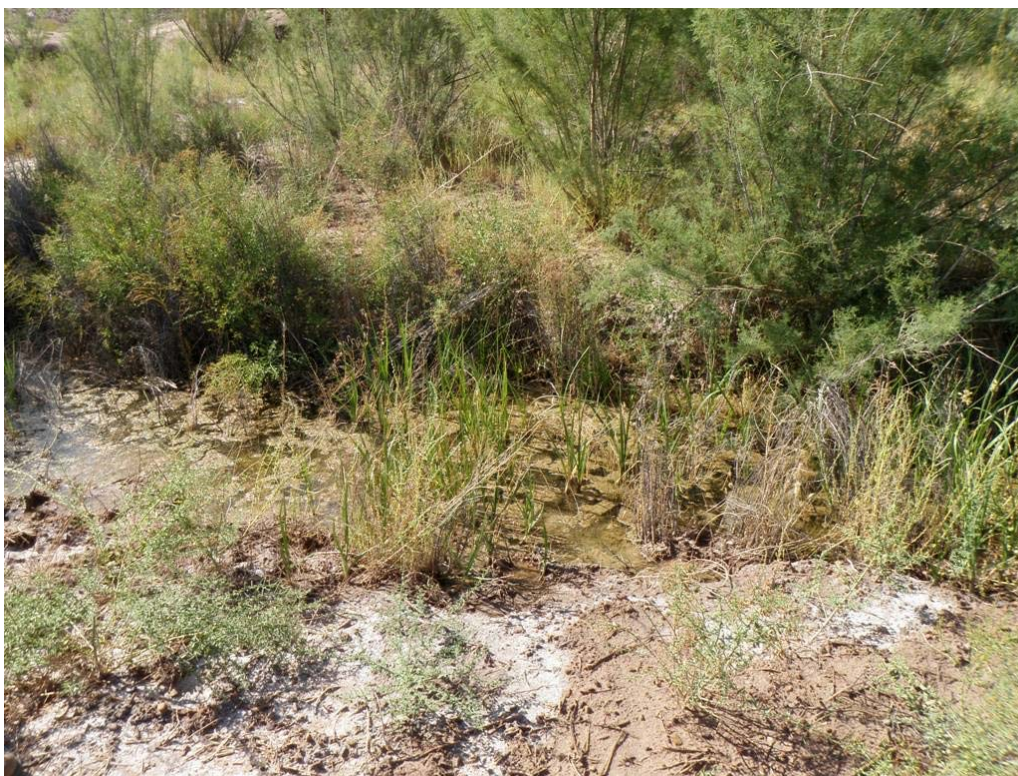
**Photo 31 – Bottom Ash Pond: Flowing surface water at Tanner Wash Seep.**

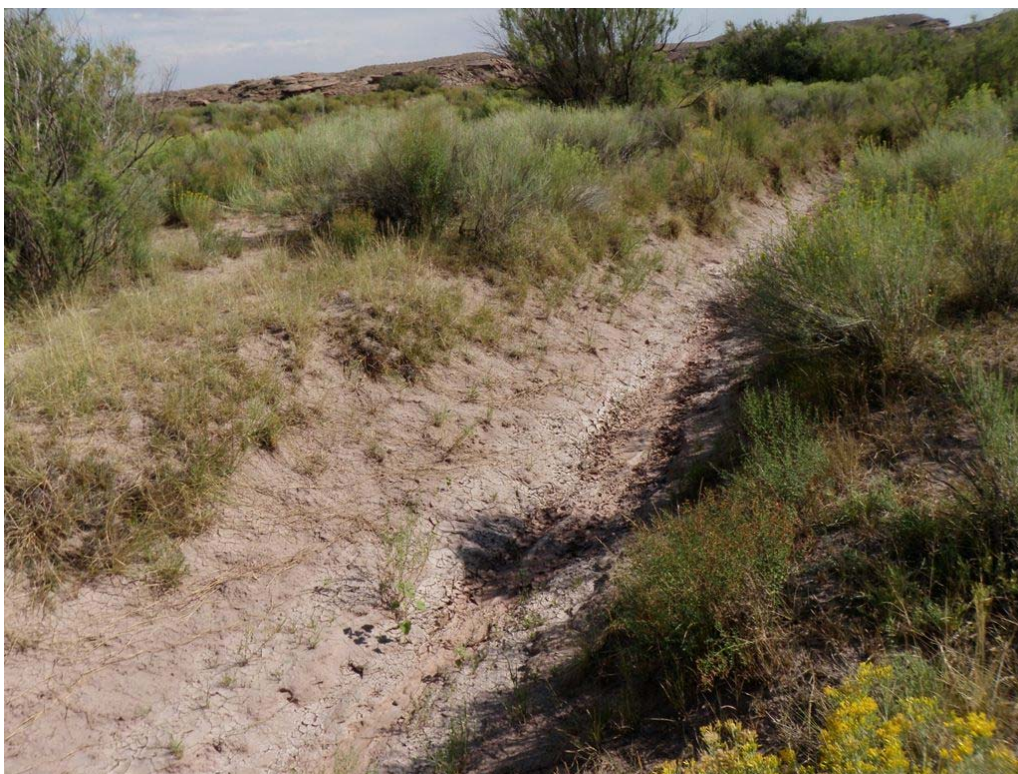
**Photo 32 – Bottom Ash Pond: Tanner Wash.**

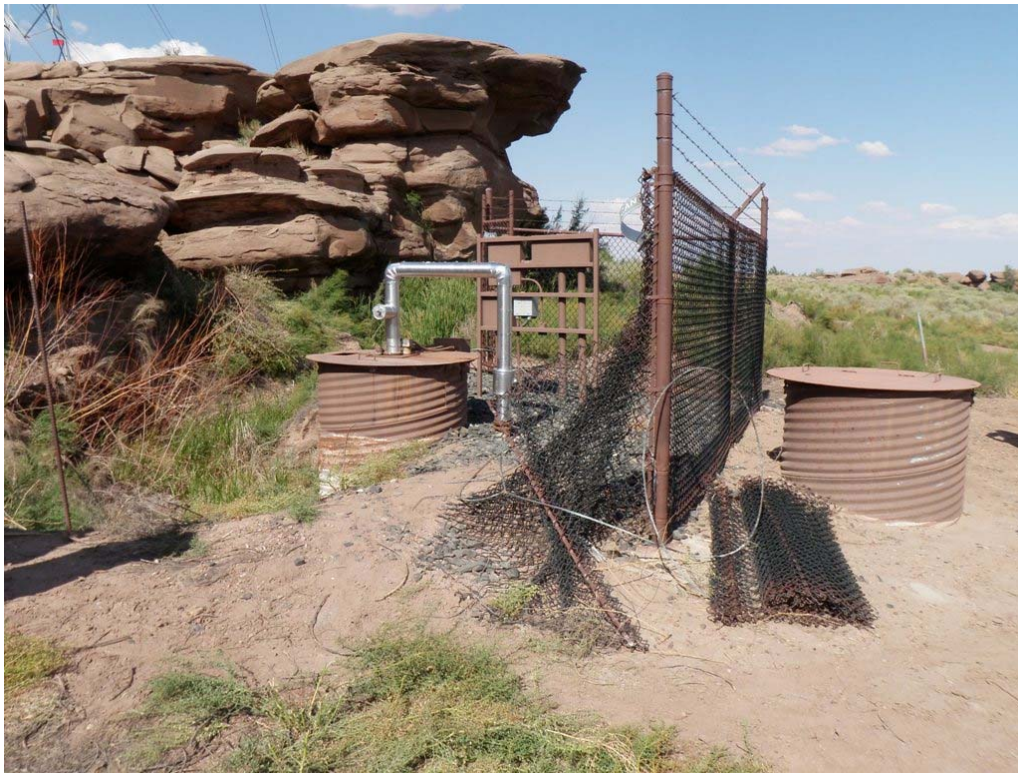
**Petroglyph Seep:** The Petroglyph Seep is located about 150 feet beyond the dam toe on the east side of the dam, south of the Tanner Wash Seep. Seepage is collected and measured via an underground french drain system with a totalizer (Photo 33). Flowing surface water was observed at this seep at the time of our assessment (Photo 34). A maximum flow of about 13 gpm has been measured at this location since 1993. This seep is far enough from the dam that it is not considered a dam safety concern.

**Photo 33 – Bottom Ash Pond: Seepage collection system for Petroglyph Seep.**

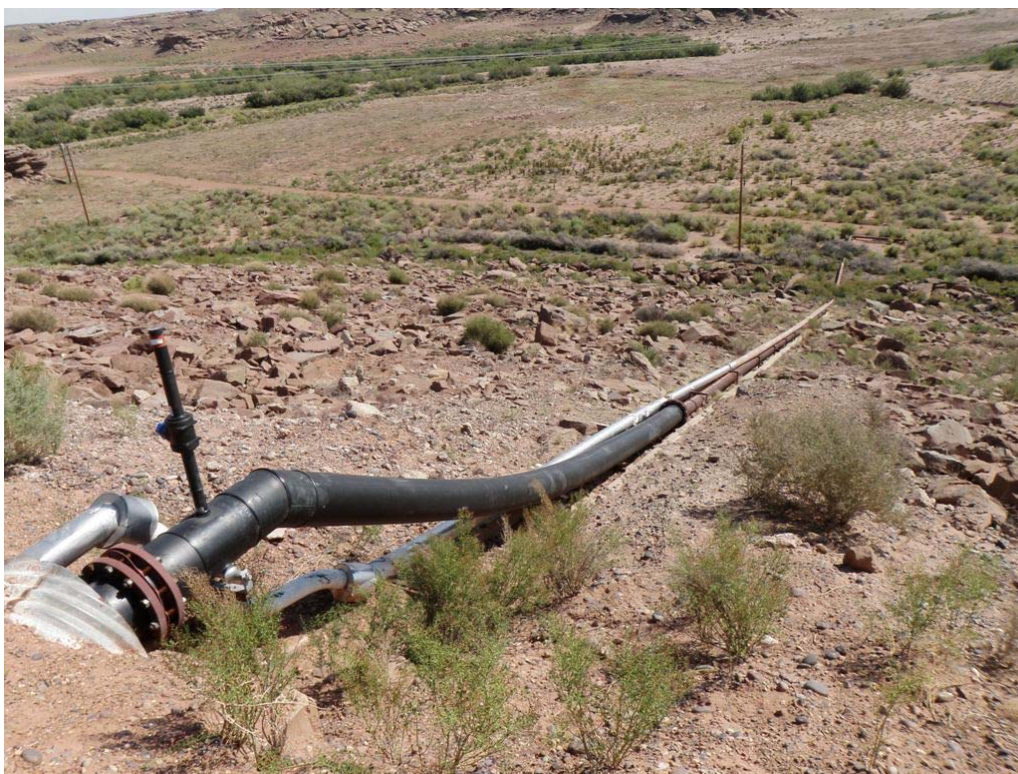
There are no spillways at either dam, and the Fly Ash Pond has no outlet. Four siphon pipes are the only outlet for the Bottom Ash Pond, and they appear to be in good condition. The siphon pipes are shown in Photos 36 (upstream side) and 37 (downstream side). The siphon

**Photo 37 – Bottom Ash Pond: Siphon pipes extending along downstream slope of dam.**
